A Supplemental Report Issued Following Hurricane Harvey

Examination of Selected Assertions by U.S.  
EPA in the Proposed Remedial Action Plan  
for the San Jacinto River Waste Pits  
Superfund Site

**Doug Shields, Jr., Ph.D., P.E., D.WRE**

October 6, 2017

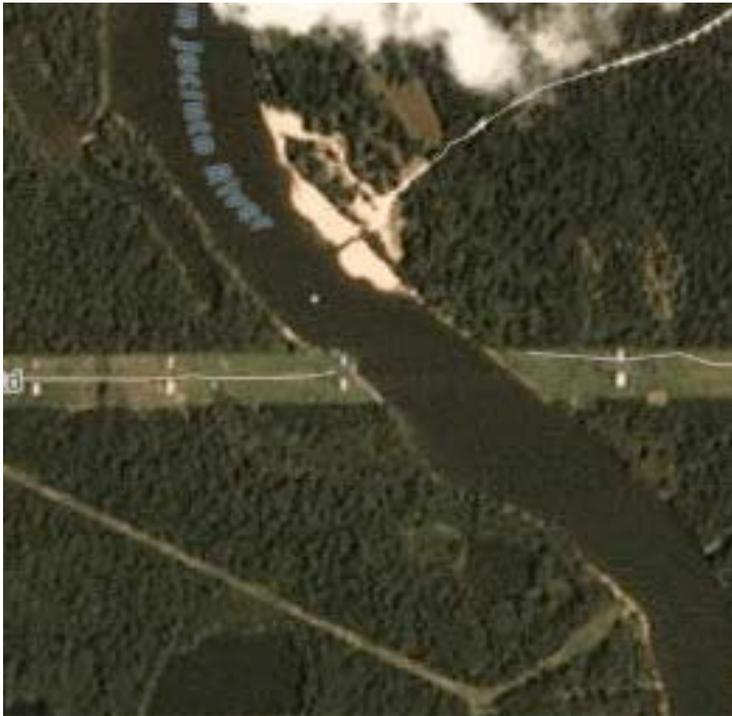
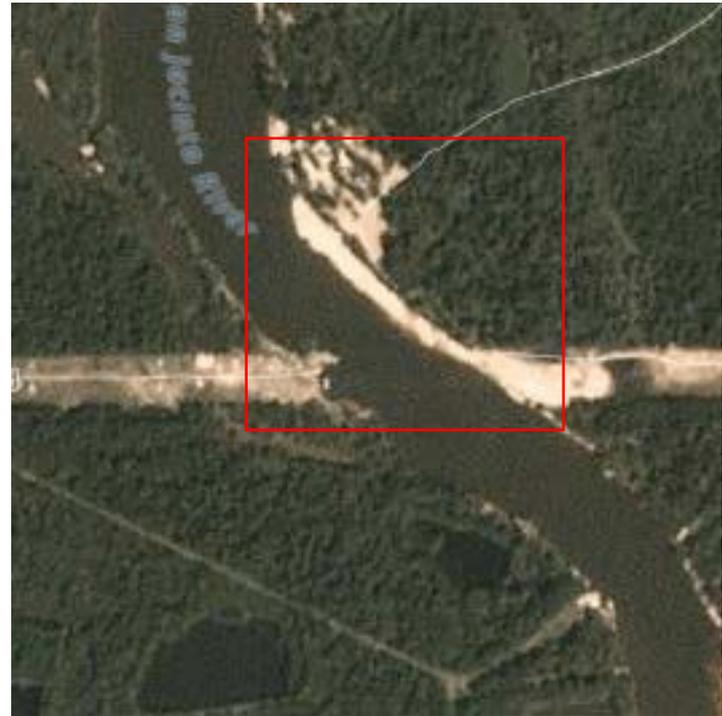
Figure 6. Comparison of pre- and post-flood coverage of San Jacinto River, Texas. Natural color infrared imagery from 4-band PlanetScope Scene (3m). Red rectangle shows area of bank erosion and deposition.

a. Bank erosion on east bank about 2.2 miles SE of Lake Houston Dam.

No major bank erosion was noted. The alignments of concave banks on the outside of bends were stable. Comparison of pre- and post-flood satellite imagery indicated bank erosion at three locations between the Lake Houston Dam and Muleshoe Lake, which is about 4.3 miles (straight line distance) upstream from the TCRA Armored Cap (Figure 6a-c). Channel width changes were limited to a reach extending about 0.6 miles up- and downstream of the U. S.

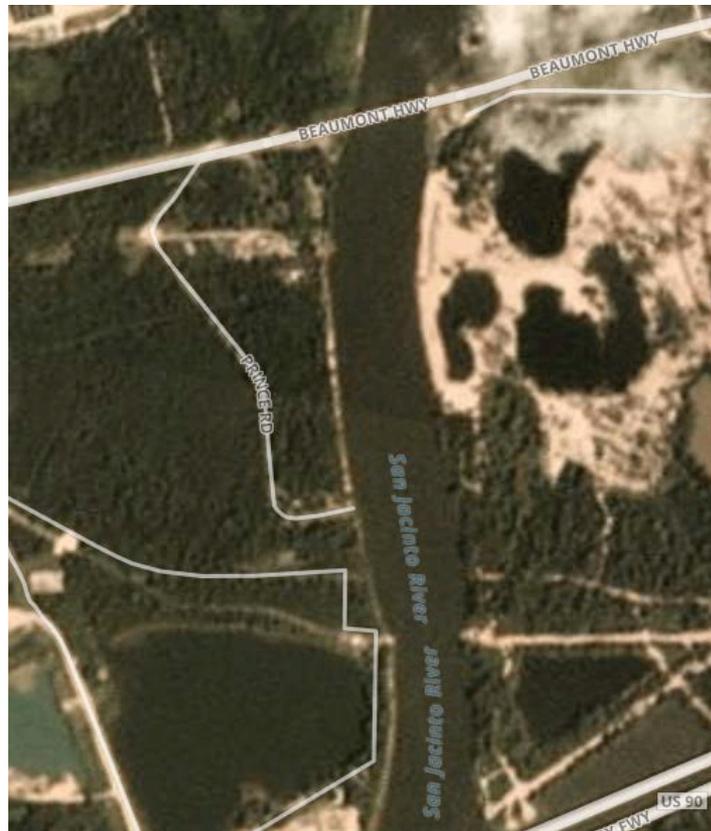
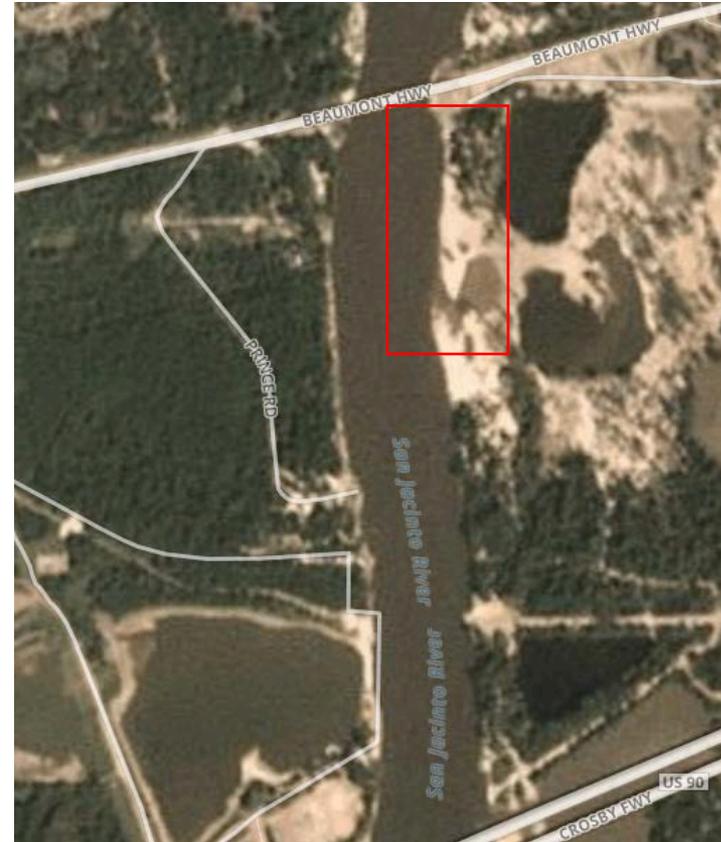
Figure 6. Comparison of pre- and post-flood coverage of San Jacinto River, Texas. Natural color infrared imagery from 4-band PlanetScope Scene (3m). Red rectangle shows area of bank erosion and deposition.

b. Bank erosion on east bank about 4.0 miles SE of Lake Houston Dam.

Highway 90 bridge, about 5.2 miles northwest of the existing TCRA Armored Cap (Figure 6b and c). The lack of erosion and deposition in the reach in which the Site is located (Figures 3d and 4d) was consistent with output from a 2D hydrodynamic computer model that was used to simulate passage of the Hurricane Harvey event (hindcasting). Maximum simulated shear stresses along the shorelines and banks in this reach during the Hurricane Harvey event were generally well below  $1 \text{ Pa} = 0.02 \text{ lb/sq ft}$  (Figure 7), implying that they were less than levels that would initiate erosion of floodplain soils (Fischenich 2001) and generally below reported levels needed to erode cohesive bank sediments (Clark and Wynn 2007, Enlow et al. 2017).

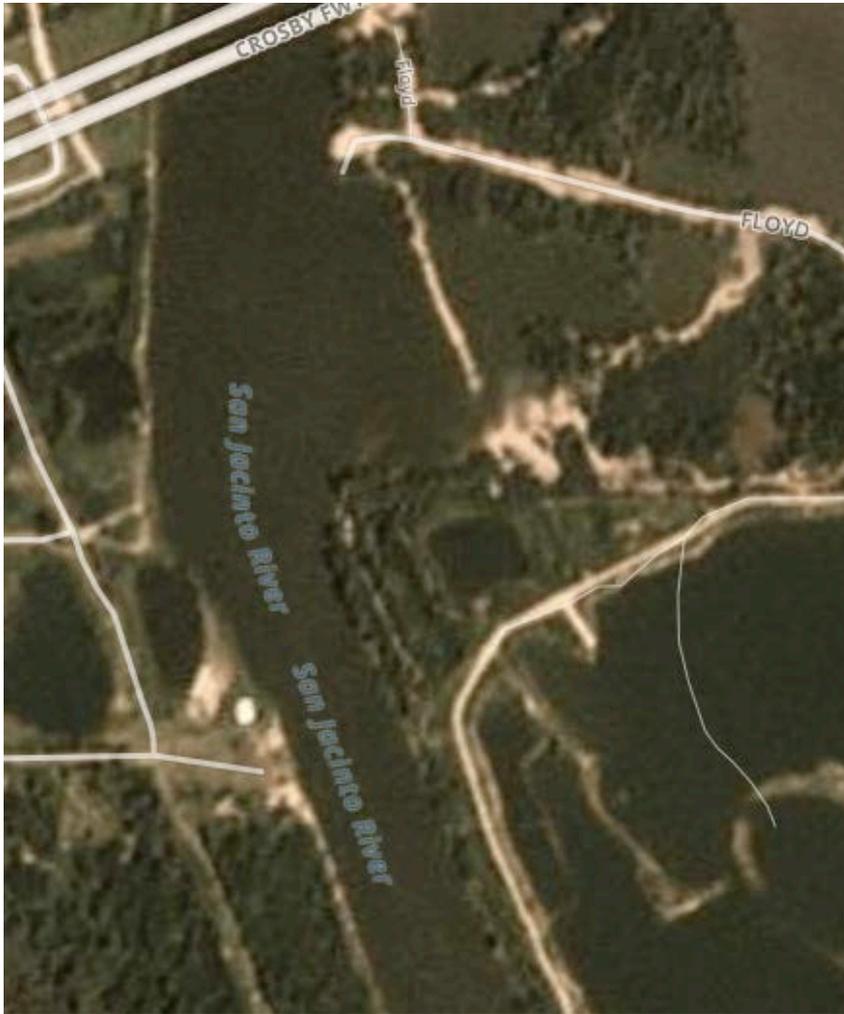
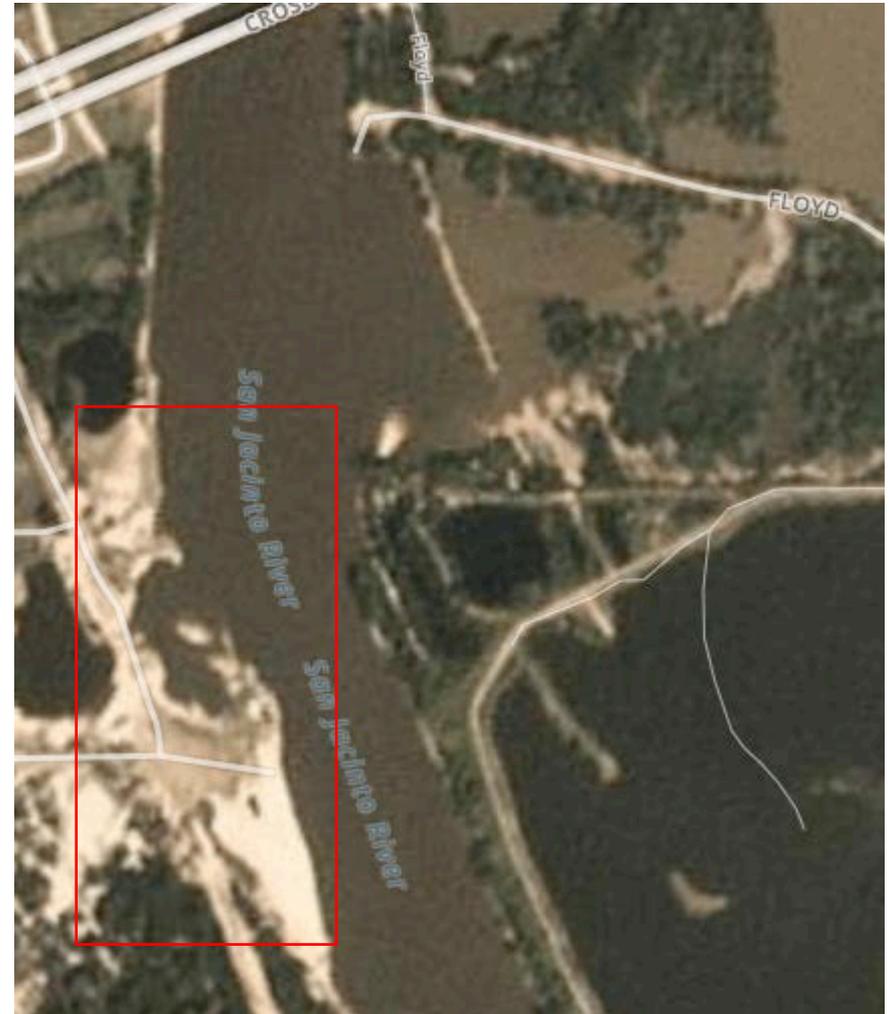
Figure 6. Comparison of pre- and post-flood coverage of San Jacinto River, Texas. Natural color infrared imagery from 4-band PlanetScope Scene (3m). Red rectangle shows area of bank erosion and deposition.

c. Bank erosion on west bank about 4.9 miles SE of Lake Houston Dam.

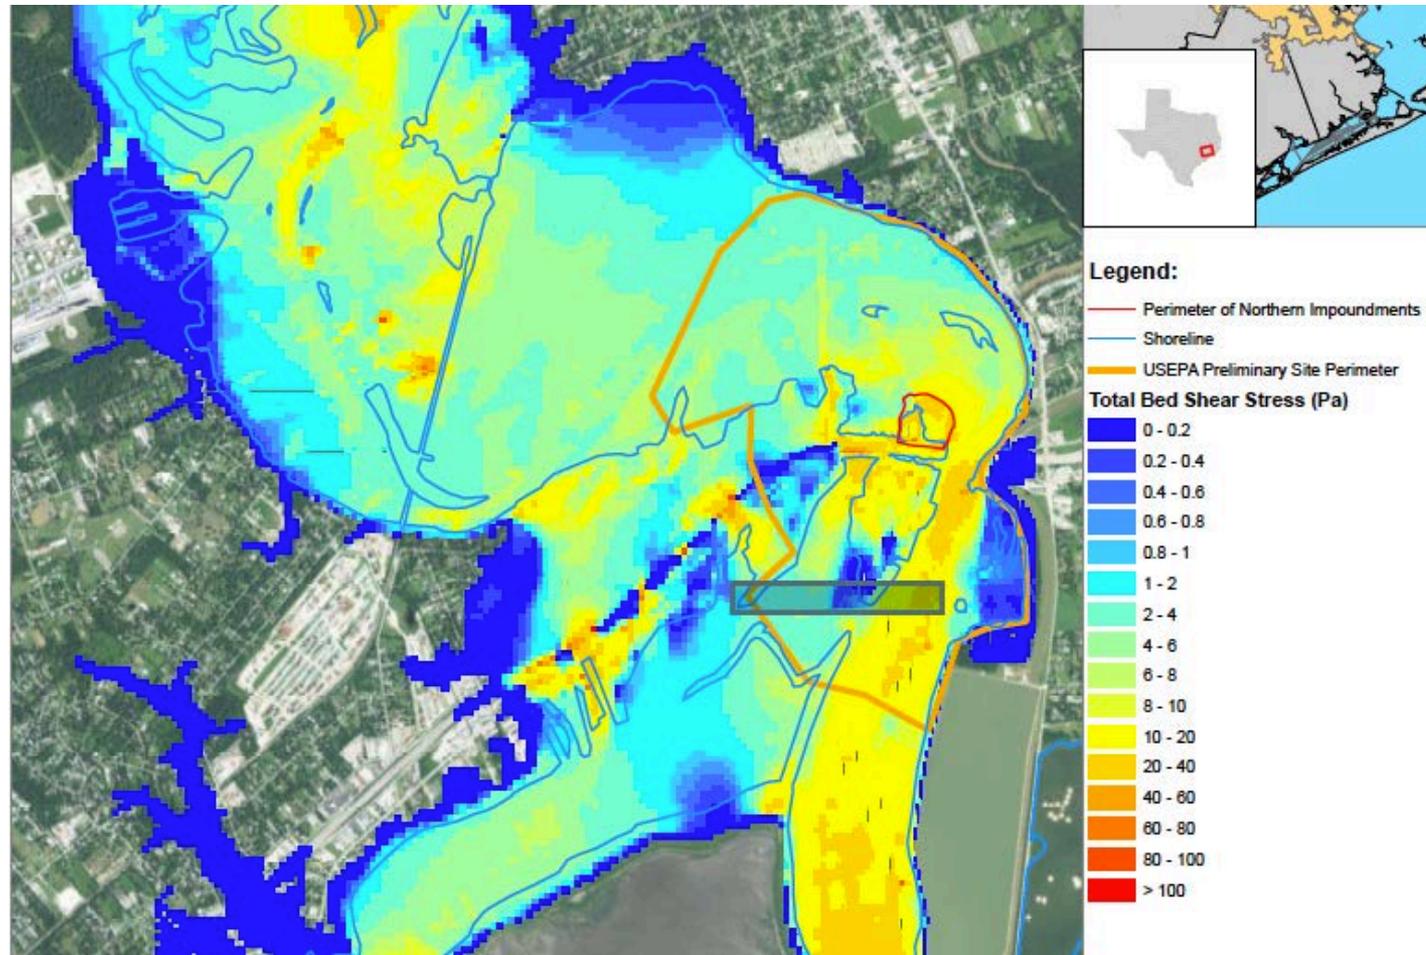
Figure 7. Simulated maximum total bed shear stress during Hurricane Harvey using Lake Houston Dam flow for calibration. Anchor QEA (unpublished).

3. I also examined output from the 2D hydrodynamic model produced by Anchor QEA that was initially developed to support design of the TCRA Armored Cap. Specifically, the output I considered was for a recent simulation of the Hurricane Harvey flood event run to hindcast depths, velocities and shear stresses on the TCRA Armored Cap and its environs (Keith et al. 2017). A map of the reach in which the Site is located indicating maximum bed shear stresses computed by the hindcast model is provided in Figure 7.

The Anchor computer model hindcast the peak Hurricane Harvey storm hydraulic stresses on the TCRA Armored Cap and indicates that maximum current velocities approached but did not exceed those used in the TCRA design (depth-averaged current velocities of 6.9 ft/s simulated vs. 8.5 ft/s used in design) (Keith et al. 2017, Anchor QEA 2010). These results are consistent with the very minor displacement of stones in the TCRA Armored Cap that were detected following Hurricane Harvey.
