Conditions on southern and central berms  
September 1, 2017

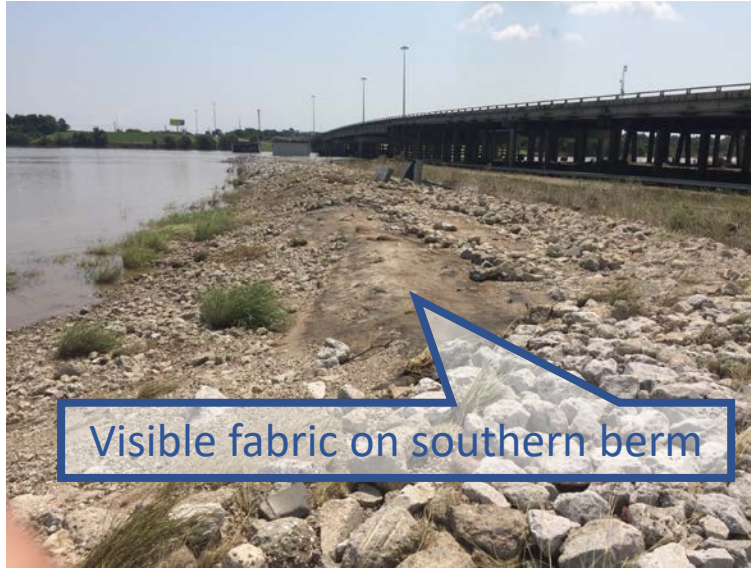
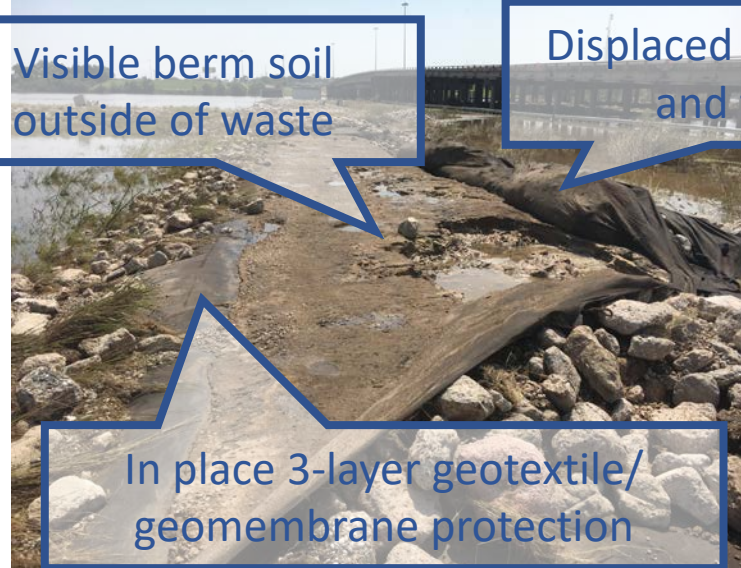
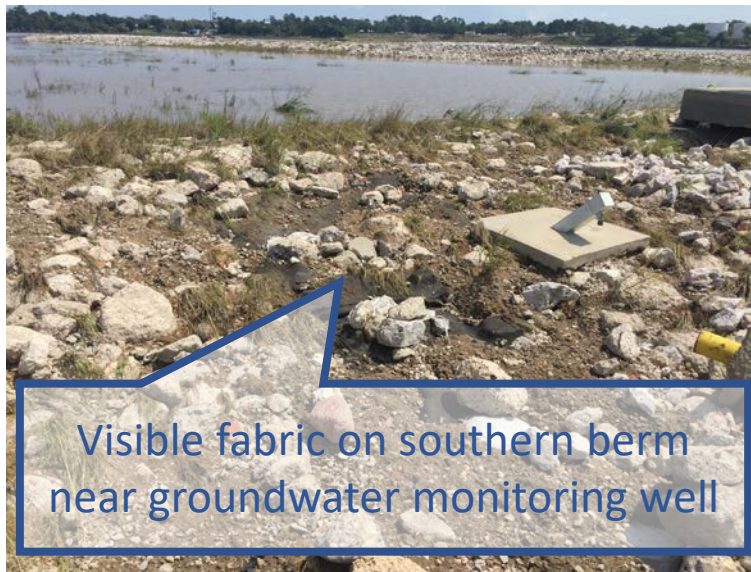
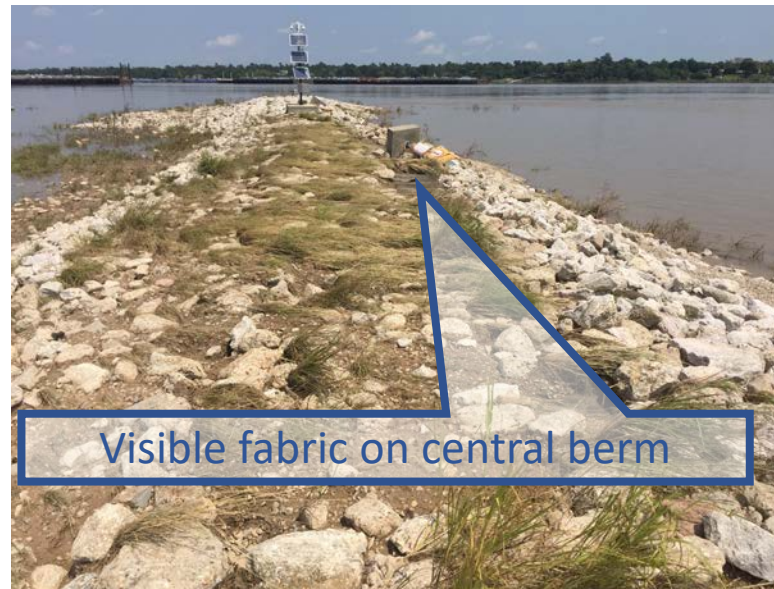
Discrete areas of armor rock on berms were displaced, outside of waste footprint

Three layer geotextile/geomembrane protection in western cell is in place and no waste was exposed

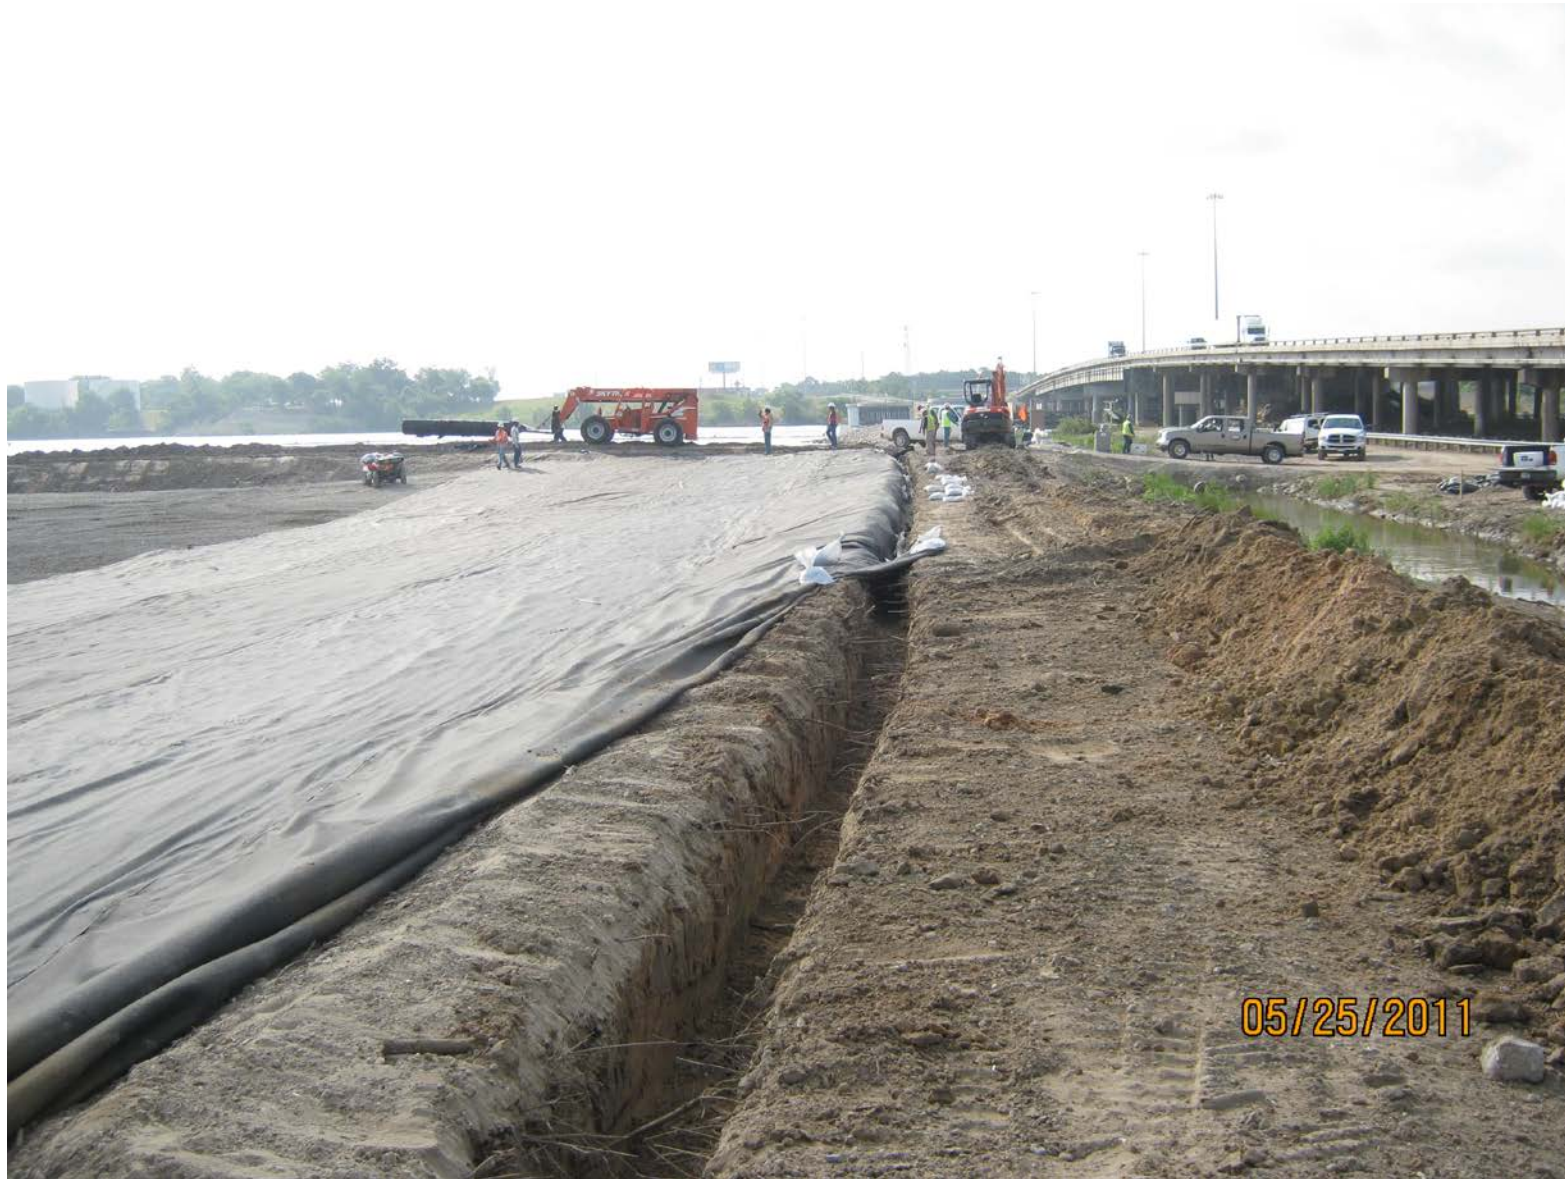
Anchor trench  
along south berm  
of west cell.

Note that anchor  
trench was dug  
into earthen  
material in the  
berm (not into  
waste)

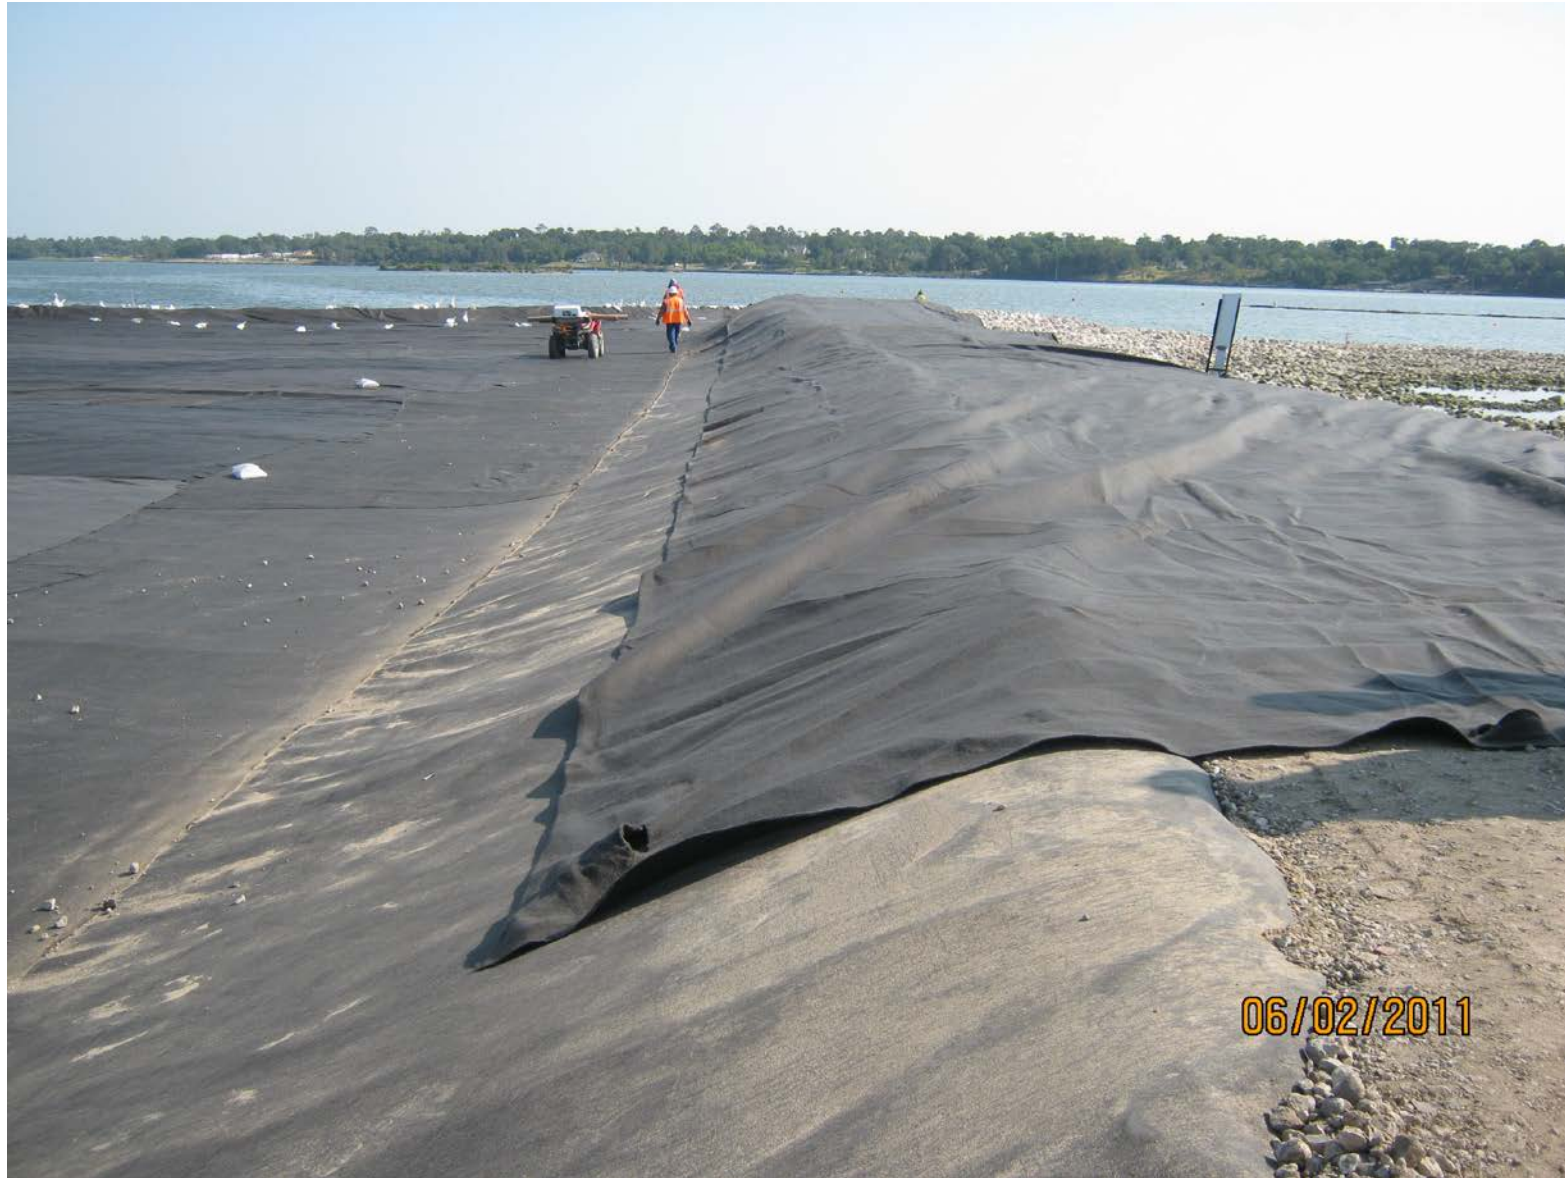
This photo is on the central berm, but it depicts how the fabric was installed over the berms – overlapping the three layer geotextile/geomembrane protection within the western cell

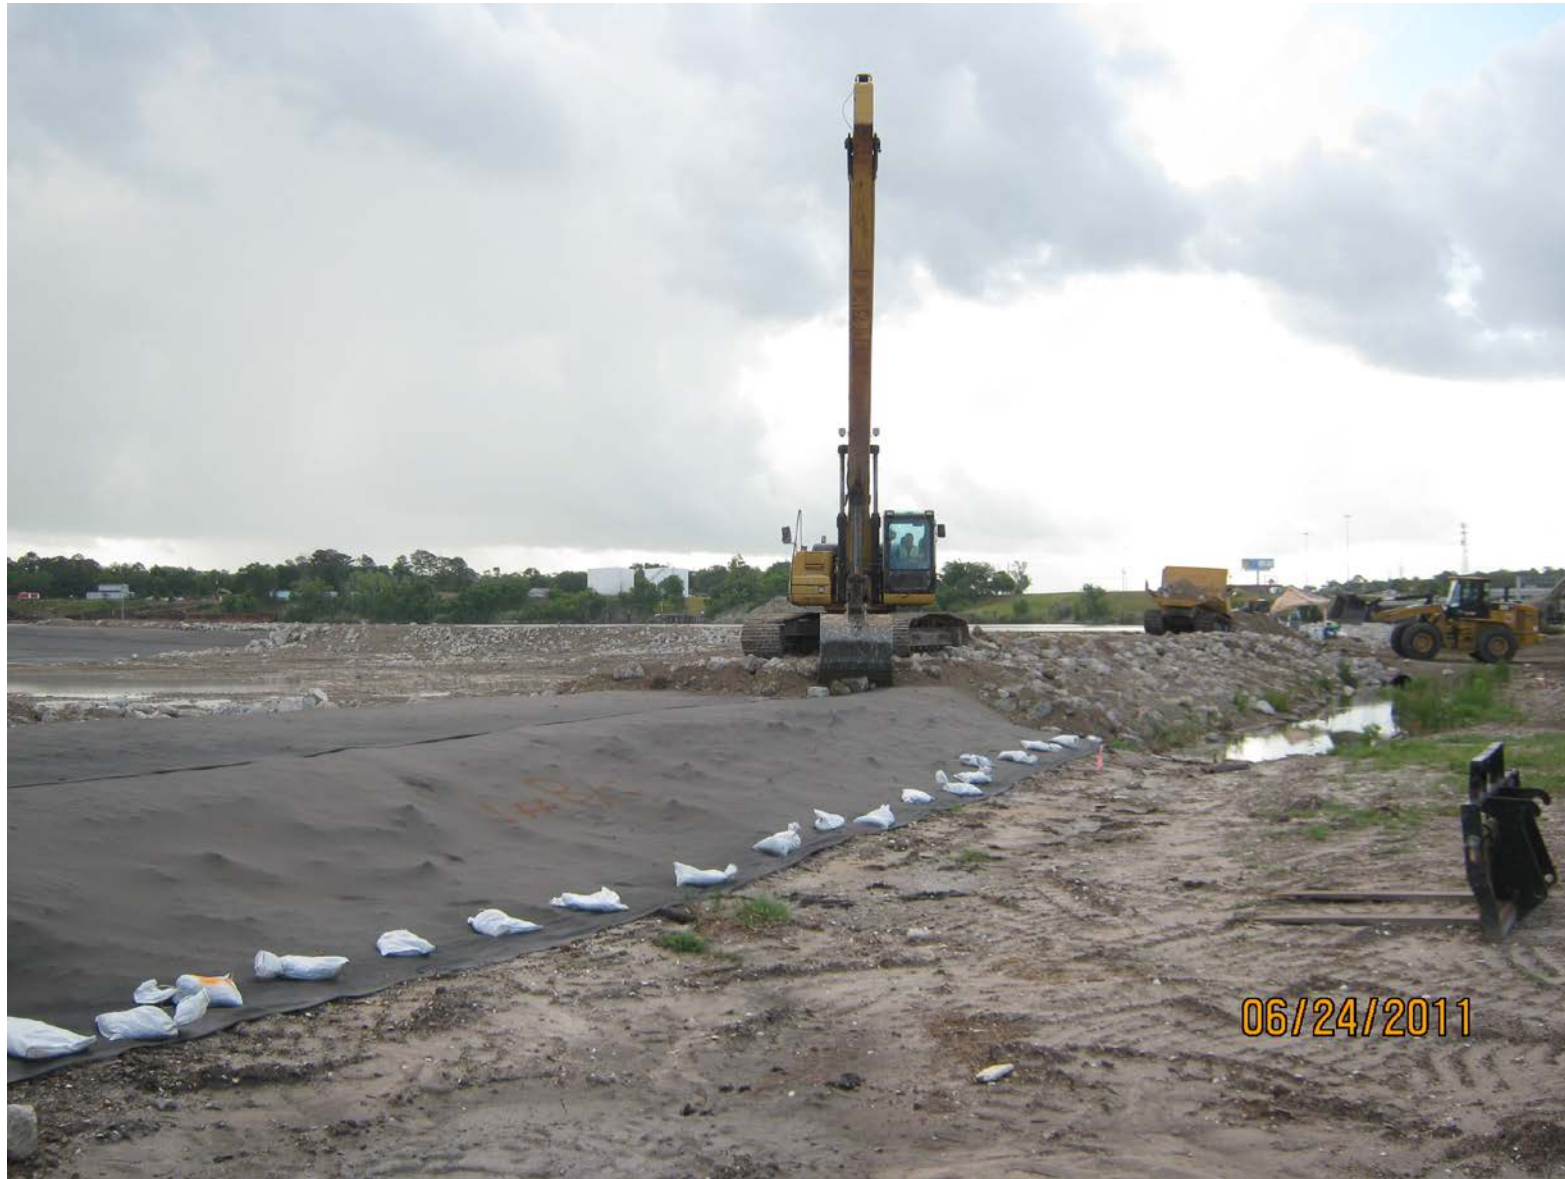
06/24/2011

Placing armor rock  
type B/C recycled  
concrete over  
fabric in the  
maintenance area  
on the south berm  
of the west cell
